**Flood Control Project Maintenance  
Levee Inspections**  
**LMA District Cover Sheet**  
**Spring 2019 Levee Inspection Results**

**Reclamation District No. 0999 Netherlands**

**Spring 2019 Levee Inspection Results**

Waterway			Bank	Unit Miles
Unit No. 01 Yolo Bypass			Left	15.41
	Spring (March - May)	Summer (June - August)	(September - November) Fall	Winter (December - February)
Unit Maintenance Rating (Fall Only)				
Date of Inspection	3/21/2019 - 3/21/2019			
DWR Inspector	Luz Dial			
Accompanied By

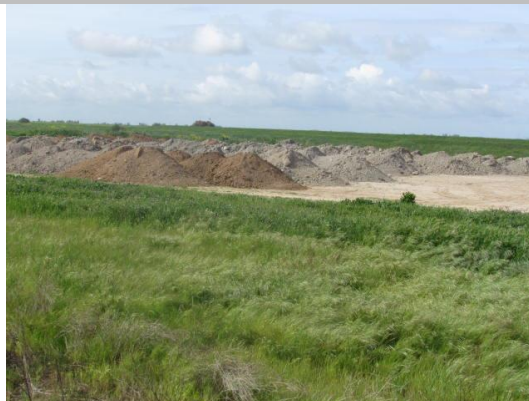
Photo 3 of 3 : SP\_2019\_RD0999\_232\_1\_20190307\_00003.jpg

Looking west at material on waterward berm.

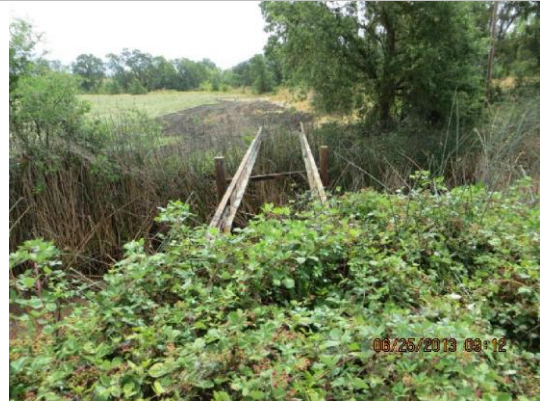
Photo 2 of 3 : UCIP\_SP\_2019\_53368\_25190.jpg

Comment Code						
Inspector Comment						
FS_ID:53368 DS_ID:22743 EP_NO: N/A Repair Type: Non-Urgent Crossing Status: Found UCIP Comments: 07/26/2018 Same as last inspection. Pipe open on WS, but no visual signs of pipe or levee integrity issues so downgrading crossing to Non-Urgent (D. Sanoski - DWR UCIP).07/07/2016 Condition largely unchanged from previous inspection. Pipe open on the WS, waterward of the siphon breaker. Dense vegetation and steep slope limited inspection of WS outlet into Ship Channel. (T. Hatch/UCIP) 06/25/2013 Pipe abandoned and open on WS slope. Pipe should be abandoned properly. (W. Wylie/UCIP) FIELD_STRUCT_DESC: *ABANDONED* 30-inch steel drainage pipe through the levee, 6.5 feet below the crown. Pump on a platform in the canal off the landside (LS) toe, not found. Flap gate on the waterside (WS), not found. Siphon breaker and an air vent on the WS shoulder. 1-inch galvanized iron filler pipe visible on the WS shoulder along same alignment. [Additional Reference(s): DWR Levee Log, 1992. USACE Sacramento O&M Manual 113 (Revised), October 1966, (HLM 1.73)]. FS Date: 7/26/2018 10:10:00 AM

Pump platform visible off LS toe, but no appurtenances remain.

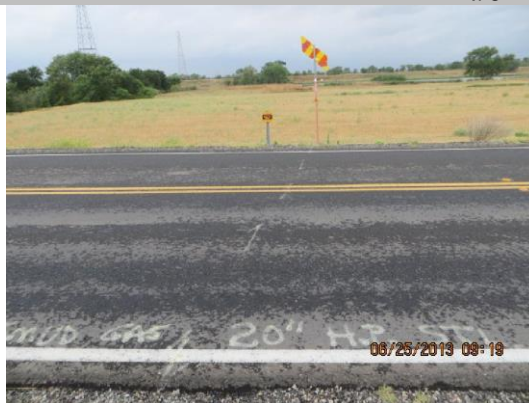
Photo 1 of 2 : UCIP\_SP\_2019\_16324\_27501.jpg

LM Start	2.09	Rating **	M	Issue No.	920
LM End	2.09	Issue Type +	En	Location *	
Category	Supplemental			GPS Latitude/Longitude	
				Start	End
Item	DWR UCIP Field Study			38.474783 °	38.474783 °
				-121.580428 °	-121.580428 °
DWR ID	23957				
Comment Code					
Inspector Comment					
FS_ID:16324 DS_ID:23957 EP_NO: N/A Repair Type: Non-Urgent Crossing Status: Found UCIP Comments: Need to determine permit for this crossing. FIELD_STRUCT_DESC: 20-inch steel gas line through the levee at an unknown depth. Gasline markers on both shoulders. (Permit No. 16311, 1996) FS Date: 6/25/2013

Gasline markers on WS shoulder with USAA paint on roadway.

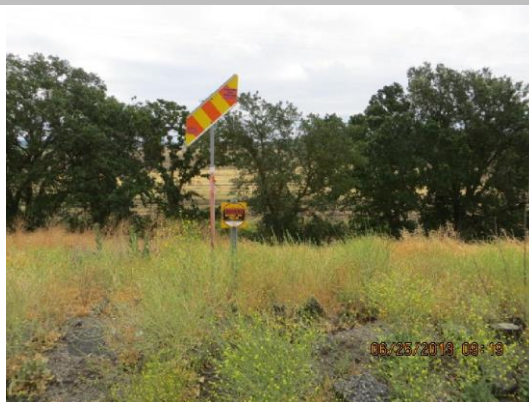
Photo 2 of 2 : UCIP\_SP\_2019\_16324\_27500.jpg

Gasline marker on LS shoulder.

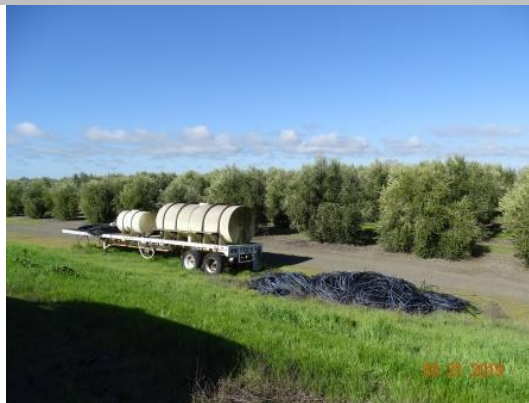
Photo 1 of 1 : SP\_2019\_RD0999\_232\_42\_20190325\_00065.jpg

View of farming equipment and materials at waterside toe. Spring 2019

LM Start	5.13	Rating **	M	Issue No.	42
LM End	5.13	Issue Type +	En	Location *	WS
Category	Earthen Levee			GPS Latitude/Longitude	
				Start	End
Item	Encroachments			38.433425 °	38.433425 °
				-121.599627 °	-121.599627 °
DWR ID	DWR_RD0999_01_s_2019_42				
Comment Code					
EQ : Equipment					
Inspector Comment					
Instruct landowner to move farming equipment to at least 10' away from the levee toe.

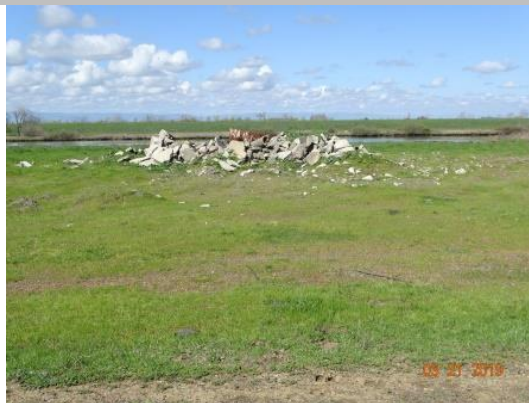
Photo 1 of 1 : SP\_2019\_RD0999\_232\_58\_20190325\_00067.jpg

View of broken concrete and equipment dumped on waterside berm.  
Spring 2019

LM Start	8.15	Rating **	M	Issue No.	58
LM End	8.15	Issue Type +	En	Location *	WS
Category	Earthen Levee			GPS Latitude/Longitude	
				Start	End
Item	Encroachments			38.392225 °	38.392225 °
				-121.618630 °	-121.618630 °
DWR ID	DWR_RD0999_01_s_2019_58				
Comment Code					
DE : Debris					
Inspector Comment					
Remove broken concrete and abandoned equipment on waterside berm.

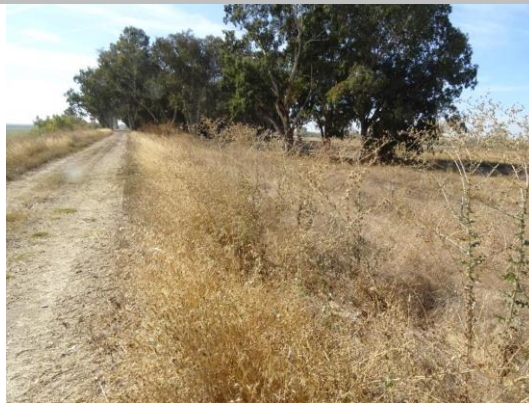
Photo 1 of 1 : SP\_2019\_RD0999\_232\_29\_20190307\_00014.jpg

View of slope vegetation that needs to be trimmed. Fall 2018

LM Start	9.64	Rating **	M	Issue No.	29
LM End	9.69	Issue Type +	Ma	Location *	WS
Category	Earthen Levee			GPS Latitude/Longitude	
				Start	End
Item	Vegetation			38.372002 °	38.371283 °
				-121.627998 °	-121.628382 °
DWR ID	DWR_RD0999_01_f_2018_29				
Comment Code					
V1 : Control annual grass and weeds on the levee slopes and easements.					
Inspector Comment					
Trim vegetation on slope.

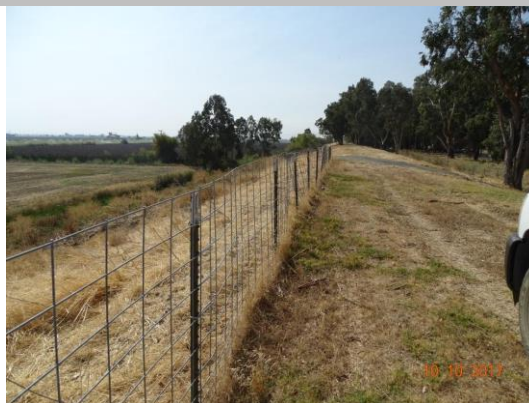
Photo 1 of 1 : SP\_2019\_RD0999\_232\_34\_20190307\_00023.jpg

View of landside slope looking south.

LM Start	9.65	Rating **	M	Issue No.	34
LM End	9.66	Issue Type +	En	Location *	LS
Category	Earthen Levee			GPS Latitude/Longitude	
				Start	End
Item	Encroachments			38.371885 °	38.371652 °
				-121.628087 °	-121.628198 °
DWR ID	DWR_RD0999_01_f_2017_34				
Comment Code					
FE : Fence					
Inspector Comment					
Instruct landowner to move fence outside of easement or apply for a CVFPB permit to authorize fence.

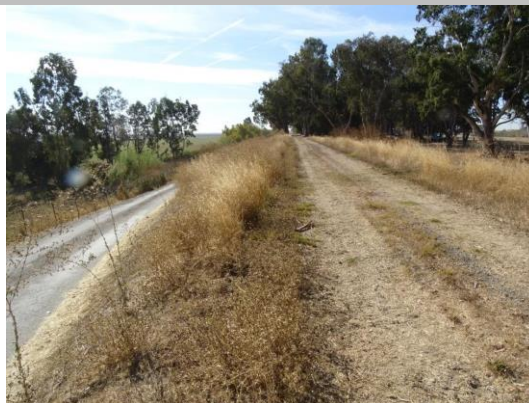
Photo 1 of 1 : SP\_2019\_RD0999\_232\_25\_20190307\_00010.jpg

View of landside vegetation that needs to be trimmed. Fall 2018

LM Start	9.68	Rating **	M	Issue No.	25
LM End	9.72	Issue Type +	Ma	Location *	LS
Category	Earthen Levee			GPS Latitude/Longitude	
				Start	End
Item	Vegetation			38.371462 °	38.370848 °
				-121.628370 °	-121.628610 °
DWR ID	DWR_RD0999_01_f_2018_25				
Comment Code					
V1 : Control annual grass and weeds on the levee slopes and easements.					
Inspector Comment					
Trim vegetation on slopes.

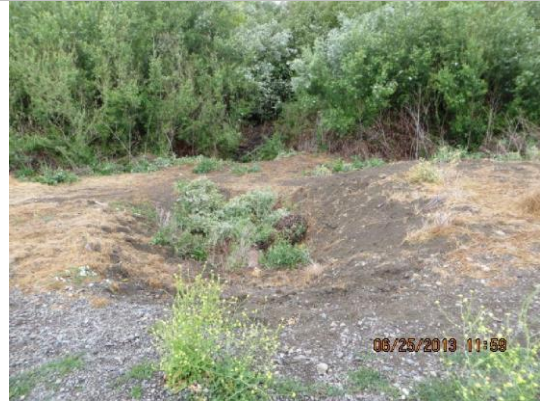
Photo 1 of 3 : UCIP\_SP\_2019\_53369\_25415.jpg

Comment Code					
Inspector Comment					
FS_ID:53369 DS_ID:22752 EP_NO: 11735 Repair Type: Urgent Crossing Status: Found UCIP Comments: 07/26/2018 Appears abandoned. WS pipe has a welded metal plate to end and LS pipe end is open. Keeping as Urgent because of levee integrity concern on WS where the levee prism has a large cut into it at the pipe discharge location (D. Sanoski - DWR UCIP).07/07/2016 - Appears abandoned. Pipe is visible in exposed cut on the WS slope of the levee. Riser on LS shoulder damaged from vandalism. welded plate on WS. No pump found on the platform in the drainage ditch. (T. Hatch/UCIP)06/25/2013 - Appears abandoned. Pipe exposed in cut on on WS slope and open at LS toe. No pump or appurtenances. (W. Wylie/UCIP) FIELD_STRUCT_DESC: *ABANDONED* 24-inch steel drainage pipe through the levee, 7 feet below the crown. Pump in a drainage ditch on the landside (LS) with a sheet pile headwall, not found. Flap gate on the waterside (WS), not found. Siphon breaker in a riser on the LS slope. (Replaced an existing 24-inch steel pipe under Permit No. 11735, 1978 - Reclamation District No. 999). [Additional Reference(s): DWR Levee Log, 1992. USACE Sacramento O&M Manual 113 (Revised), October 1966, (HLM 12.29)]. FS Date: 7/26/2018 10:16:00 AM

Pipe visible in exposed cut on WS slope.

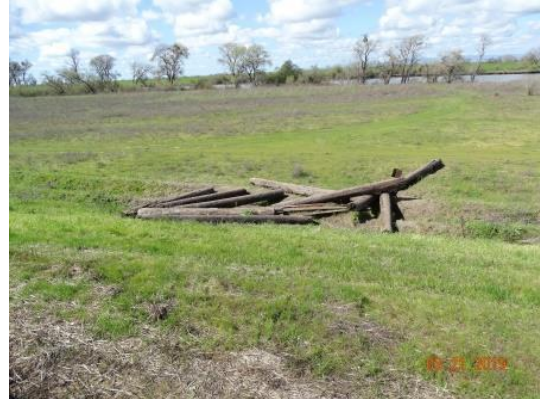
Photo 1 of 1 : SP\_2019\_RD0999\_232\_59\_20190325\_00068.jpg

View of utility pole debris left on waterside toe. Spring 2019

LM Start	12.35	Rating **	M	Issue No.	59
LM End	12.35	Issue Type +	En	Location *	WS
Category	Earthen Levee			GPS Latitude/Longitude	
				Start	End
Item	Encroachments			38.334773 °	38.334773 °
				-121.644238 °	-121.644238 °
DWR ID	DWR_RD0999_01_s_2019_59				
Comment Code					
DE : Debris					
Inspector Comment					
Remove utility pole debris at waterside toe.

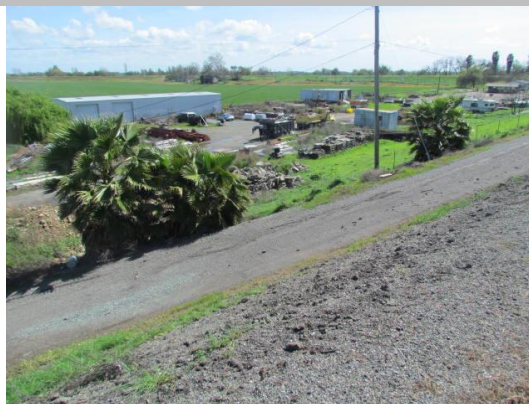
Photo 1 of 2 : SP\_2019\_RD0999\_232\_44\_20190307\_00027.jpg

Looking east at palm trees on landward slope next to ramp.

LM Start	15.26	Rating **	U	Issue No.	44
LM End	15.47	Issue Type +	En	Location *	WS
Category	Earthen Levee			GPS Latitude/Longitude	
				Start	End
Item	Vegetation			38.292702 °	38.290482 °
				-121.644967 °	-121.643790 °
DWR ID	DWR_RD0999_01_s_2016_44				
Comment Code					
V6 : Landscaping					
Inspector Comment					
Instruct landowner to apply for a CVFPB permit to authorize palm trees planted on landward slope and toe.

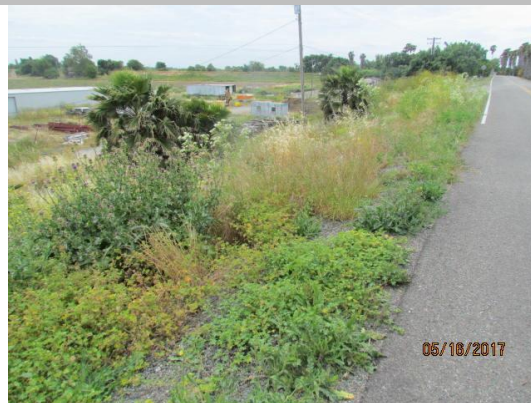
Photo 2 of 2 : SP\_2019\_RD0999\_232\_44\_20190307\_00028.jpg

LM Start	15.26	Rating **	U	Issue No.	44 (cont)	
LM End	15.47	Issue Type +	En	Location *	WS	
Category	Earthen Levee			GPS Latitude/Longitude		
				Start		End
Item	Vegetation			38.292702 °		38.290482 °
				-121.644967 °		-121.643790 °
DWR ID	DWR_RD0999_01_s_2016_44					
Comment Code						
V6 : Landscaping						
Inspector Comment						
Instruct landowner to apply for a CVFPB permit to authorize palm trees planted on landward slope and toe.

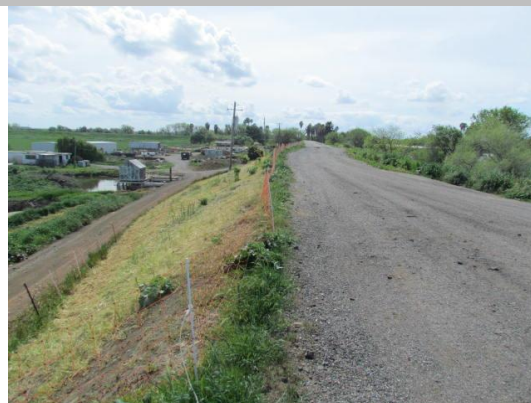
Photo 1 of 3 : SP\_2019\_RD0999\_232\_39\_20190307\_00024.jpg

LM Start	15.27	Rating **	M	Issue No.	39
LM End	15.41	Issue Type +	En	Location *	LS
Category	Earthen Levee			GPS Latitude/Longitude	
				Start	End
Item	Encroachments			38.292578 °	38.290525 °
				-121.644972 °	-121.644902 °
DWR ID	DWR_RD0999_01_s_2012_39				
Comment Code					
FE : Fence					
Inspector Comment					
Instruct landowner to move fence outside of easement or apply for a CVFPB permit to authorize fence along landside slope. Landowner added additional fencing on landward shoulder and slope.

Looking east at fencing on landward shoulder and slope. (Spring 2015)

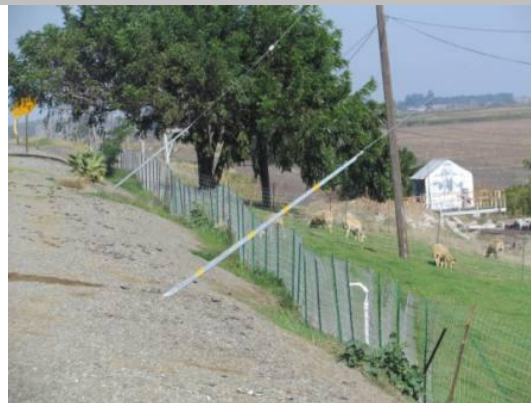
Photo 2 of 3 : SP\_2019\_RD0999\_232\_39\_20190307\_00025.jpg

Looking north at fence along landside slope.

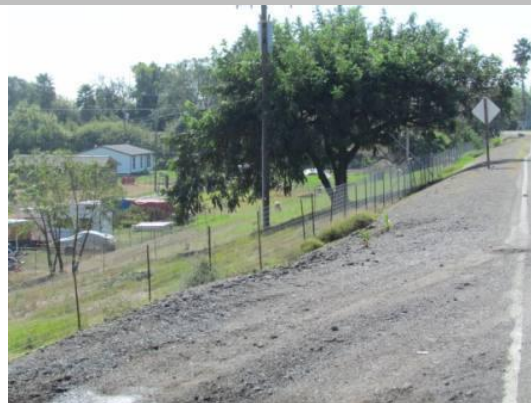
Photo 3 of 3 : SP\_2019\_RD0999\_232\_39\_20190307\_00026.jpg

LM Start	15.27	Rating **	M	Issue No.	39 (cont)	
LM End	15.41	Issue Type +	En	Location *	LS	
Category	Earthen Levee			GPS Latitude/Longitude		
				Start		End
Item	Encroachments			38.292578 °		38.290525 °
				-121.644972 °		-121.644902 °
DWR ID	DWR_RD0999_01_s_2012_39					
Comment Code						
FE : Fence						
Inspector Comment						
Instruct landowner to move fence outside of easement or apply for a CVFPB permit to authorize fence along landside slope. Landowner added additional fencing on landward shoulder and slope.

Looking south at fence along landside slope.

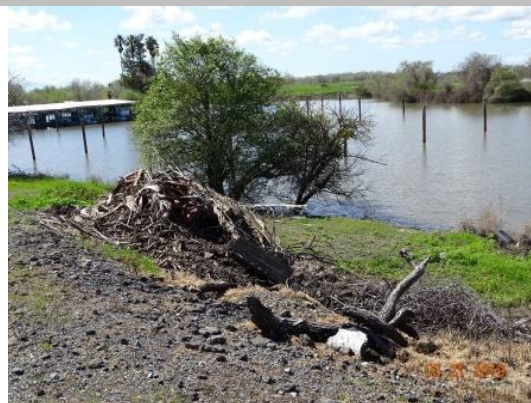
Photo 1 of 2 : SP\_2019\_RD0999\_232\_45\_20190325\_00071.jpg

LM Start	15.28	Rating **	M	Issue No.	45
LM End	15.28	Issue Type +	En	Location *	WS
Category	Earthen Levee			GPS Latitude/Longitude	
				Start	End
Item	Encroachments			38.292360 °	38.292360 °
				-121.644968 °	-121.644968 °
DWR ID	DWR_RD0999_01_s_2017_45				
Comment Code					
PR : Prunings					
Inspector Comment					
Remove prunings and utility poles from waterside slope.

View of prunings left on waterside slope. Spring 2019

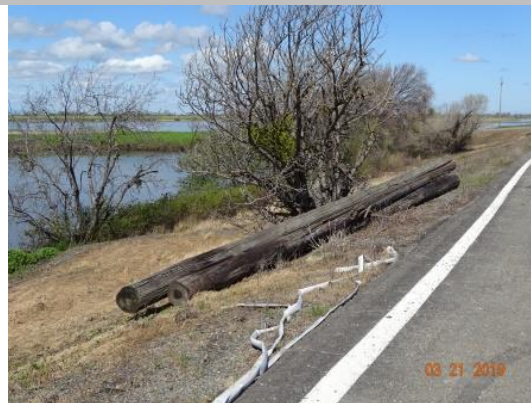
Photo 2 of 2 : SP\_2019\_RD0999\_232\_45\_20190325\_00072.jpg

View of utility poles left on waterside slope. Spring 2019

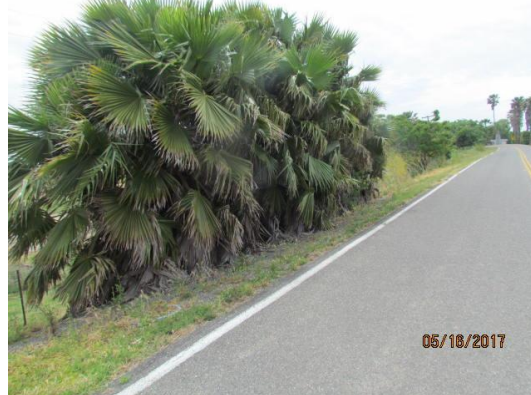
Photo 1 of 1 : SP\_2019\_RD0999\_232\_50\_20190307\_00030.jpg

LM Start	15.33	Rating **	U	Issue No.	50
LM End	15.33	Issue Type +	En	Location *	LS
Category	Earthen Levee			GPS Latitude/Longitude	
				Start	End
Item	Encroachments			38.291663 °	38.291663 °
				-121.644962 °	-121.644962 °
DWR ID	DWR_RD0999_01_f_2012_50				
Comment Code					
TR : Tree or limb					
Inspector Comment					
Instruct landowner to apply for a CVFPB permit to authorize palm trees planted on landside shoulder.

Looking east at palm trees (Spring 2017)

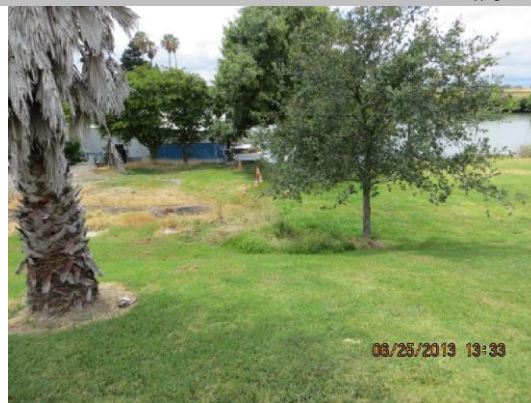
Photo 1 of 3 : UCIP\_SP\_2019\_16330\_27512.jpg

LM Start	15.36	Rating **	M	Issue No.	926
LM End	15.36	Issue Type +	En	Location *	
Category	Supplemental			GPS Latitude/Longitude	
				Start	End
Item	DWR UCIP Field Study			38.291192 °	38.291192 °
				-121.644987 °	-121.644987 °
DWR ID	23970				
Comment Code					
Inspector Comment					
FS_ID:16330 DS_ID:23970 EP_NO: N/A Repair Type: Non-Urgent Crossing Status: Found UCIP Comments: No permit identified for this crossing. FIELD_STRUCT_DESC: 4-inch polyvinyl chloride (PVC) water line through the levee, 2 feet below the crown. Pump off the waterside (WS) toe visible at the water's edge. FS Date: 6/25/2013

Pipe visible at WS toe in grass.

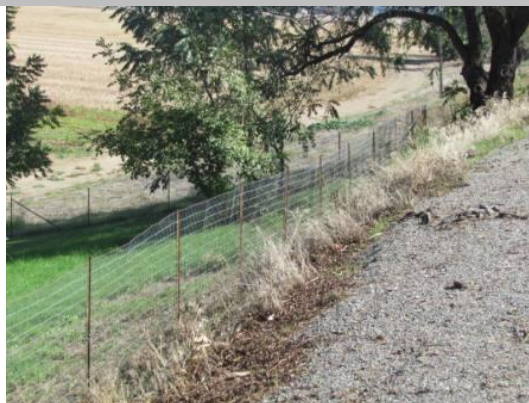
Photo 3 of 3 : SP\_2019\_RD0999\_233\_17\_20190307\_00016.jpg

Looking northeast at fence along landside shoulder.

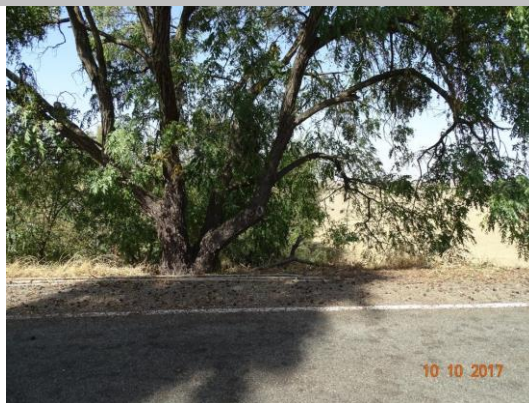
Photo 1 of 1 : SP\_2019\_RD0999\_233\_21\_20190307\_00019.jpg

LM Start	0.06	Rating **	M	Issue No.	21
LM End	0.06	Issue Type +	Ma	Location *	LS
Category	Earthen Levee			GPS Latitude/Longitude	
				Start	End
Item	Trim / Thin Trees			38.290434 °	38.290434 °
				-121.643873 °	-121.643873 °
DWR ID	DWR_RD0999_02_f_2017_21				
Comment Code					
T1 : Trim trees to at least five feet above ground level.					
Inspector Comment

View of landside slope looking north. Fall 2017

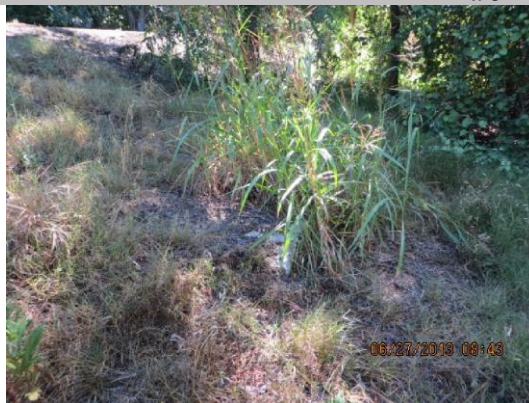
Photo 2 of 3 : UCIP\_SP\_2019\_15384\_25241.jpg

LM Start	0.79	Rating **	M	Issue No.	39 (cont)	
LM End	0.79	Issue Type +	En	Location *		
Category	Supplemental			GPS Latitude/Longitude		
				Start		End
Item	DWR UCIP Field Study			38.292562 °		38.292562 °
				-121.631331 °		-121.631331 °
DWR ID	22772					
Comment Code						
Inspector Comment						
FS_ID:15384 DS_ID:22772 EP_NO: N/A Repair Type: Non-Urgent Crossing Status: Found UCIP Comments: Pipe open on both ends. Pumphouse has been removed. Needs to be abandoned properly. FIELD_STRUCT_DESC: *ABANDONED* 8-inch steel irrigation pipe through the levee, 4.5 feet below the crown. Abandoned pump house on the waterside (WS) slope. [Additional Reference(s): DWR Levee Log, 1992. USACE Sacramento O&M Manual 113 (Revised), October 1966, (HLM 0.78)]. FS Date: 6/27/2013

Concrete pad on WS slope.

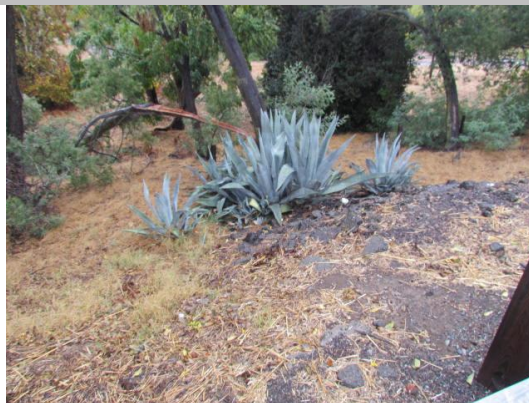
Photo 1 of 2 : SP\_2019\_RD0999\_233\_14\_20190307\_00012.jpg

LM Start	0.82	Rating **	M	Issue No.	14
LM End	0.82	Issue Type +	Ma	Location *	LS
Category	Earthen Levee			GPS Latitude/Longitude	
				Start	End
Item	Vegetation			38.292439 °	38.292439 °
				-121.630781 °	-121.630781 °
DWR ID	DWR_RD0999_02_f_2012_14				
Comment Code					
V2 : Remove the wild growth other than native grasses from the levee slopes.					
Inspector Comment					
LMA has not removed Century plant on landside slope.

Looking north at century plant at landward toe. Fall 2015.

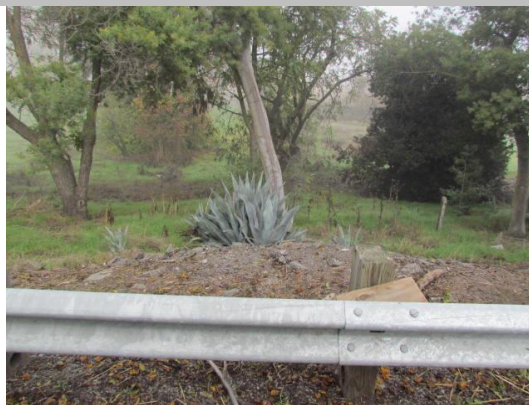
Photo 2 of 2 : SP\_2019\_RD0999\_233\_14\_20190307\_00013.jpg

Looking north at century plant at landside toe.

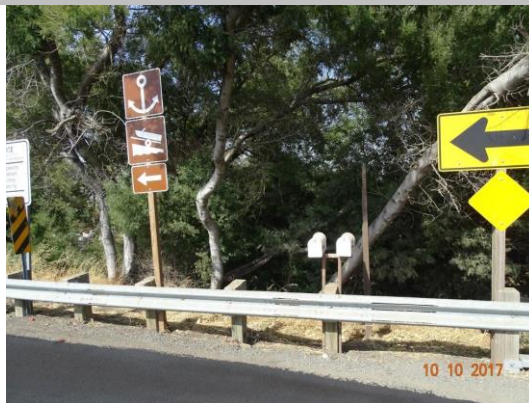
Photo 1 of 2 : SP\_2019\_RD0999\_233\_19\_20190307\_00017.jpg

LM Start	0.83	Rating **	M	Issue No.	19
LM End	0.83	Issue Type +	Ma	Location *	LS
Category	Earthen Levee			GPS Latitude/Longitude	
				Start	End
Item	Trim / Thin Trees			38.292386 °	38.292386 °
				-121.630543 °	-121.630543 °
DWR ID	DWR_RD0999_02_f_2012_19				
Comment Code					
T2 : Thin trees to allow visibility of the ground and room to flood fight.					
Inspector Comment

View of landside slope looking north. Fall 2017

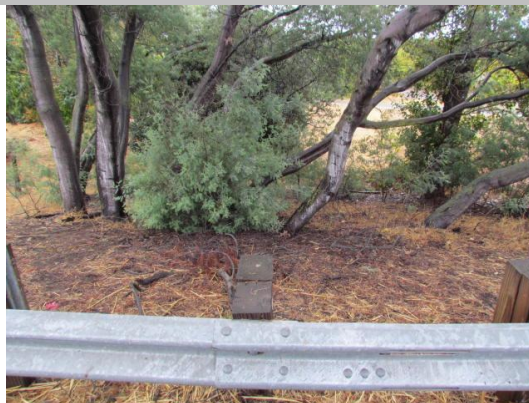
Photo 2 of 2 : SP\_2019\_RD0999\_233\_19\_20190307\_00018.jpg

LM Start	0.83	Rating **	M	Issue No.	19 (cont)	
LM End	0.83	Issue Type +	Ma	Location *	LS	
Category	Earthen Levee			GPS Latitude/Longitude		
				Start		End
Item	Trim / Thin Trees			38.292386 °		38.292386 °
				-121.630543 °		-121.630543 °
DWR ID	DWR_RD0999_02_f_2012_19					
Comment Code						
T2 : Thin trees to allow visibility of the ground and room to flood fight.						
Inspector Comment

Looking north at untrimmed and trees to be thinned at landward toe fall 2015.

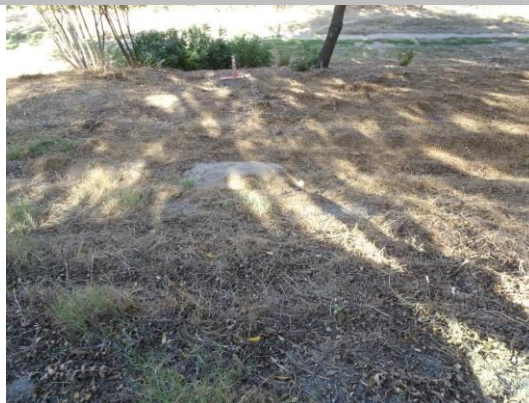
Photo 1 of 2 : SP\_2019\_RD0999\_233\_2\_20190307\_00001.jpg

LM Start	0.93	Rating **	A/W	Issue No.	2
LM End	1.03	Issue Type +	Ma	Location *	LS
Category	Earthen Levee			GPS Latitude/Longitude	
				Start	End
Item	Animal Control			38.291823 °	38.291250 °
				-121.628973 °	-121.627285 °
DWR ID	DWR_RD0999_02_s_2012_2				
Comment Code					
A1 : Exterminate rodents and backfill and compact or grout burrows.					
Inspector Comment					
LMA backfilled holes and has an active baiting program.

View of backfilled rodent holes. Fall 2018

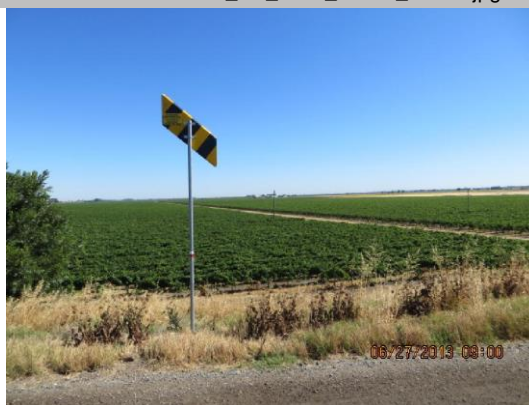
Photo 1 of 3 : UCIP\_SP\_2019\_16331\_27516.jpg

LM Start	1.02	Rating **	M	Issue No.	41	
LM End	1.02	Issue Type +	En	Location *		
Category	Supplemental			GPS Latitude/Longitude		
				Start		End
Item	DWR UCIP Field Study			38.291252 °		38.291252 °
				-121.627398 °		-121.627398 °
DWR ID	23961					
Comment Code						
Inspector Comment						
FS_ID:16331						
DS_ID:23961						
EP_NO: N/A						
Repair Type: Non-Urgent						
Crossing Status: Found						
UCIP Comments: Need to determine permit for this crossing.						
FIELD_STRUCT_DESC: Gas line through the levee at an unknown depth. Markers on both shoulders.						
FS Date: 6/27/2013

Gasline marker on LS shoulder.

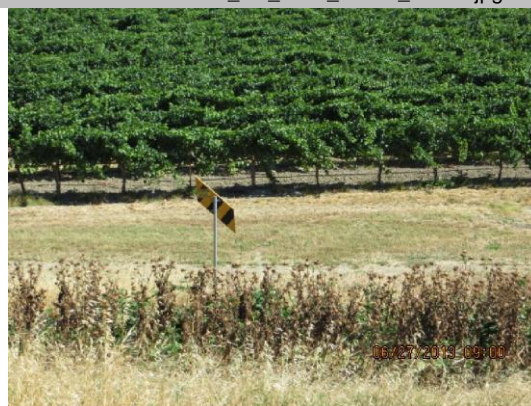
Photo 2 of 3 : UCIP\_SP\_2019\_16331\_27515.jpg

LM Start	1.02	Rating **	M	Issue No.	41 (cont)	
LM End	1.02	Issue Type +	En	Location *		
Category	Supplemental			GPS Latitude/Longitude		
				Start	End	
Item	DWR UCIP Field Study			38.291252 °	38.291252 °	
				-121.627398 °	-121.627398 °	
DWR ID	23961					
Comment Code						
Inspector Comment						
FS_ID:16331 DS_ID:23961 EP_NO: N/A Repair Type: Non-Urgent Crossing Status: Found UCIP Comments: Need to determine permit for this crossing. FIELD_STRUCT_DESC: Gas line through the levee at an unknown depth. Markers on both shoulders. FS Date: 6/27/2013

Gasline marker on LS toe.

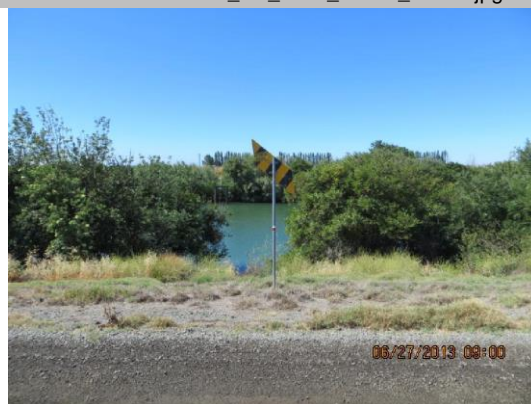
Photo 3 of 3 : UCIP\_SP\_2019\_16331\_27514.jpg

Gasline marker on WS shoulder.

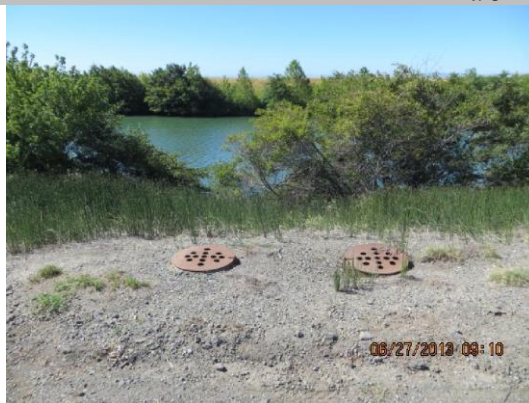
Photo 1 of 3 : UCIP\_SP\_2019\_16334\_27527.jpg

LM Start	1.25	Rating **	M	Issue No.	43
LM End	1.25	Issue Type +	En	Location *	
Category	Supplemental			GPS Latitude/Longitude	
				Start	End
Item	DWR UCIP Field Study			38.291381 °	38.291381 °
				-121.623268 °	-121.623268 °
DWR ID	23963				
Comment Code					
Inspector Comment					
FS_ID:16334					
DS_ID:23963					
EP_NO: N/A					
Repair Type: Non-Urgent					
Crossing Status: Found					
UCIP Comments: Need to determine permit No. for this crossing.					
FIELD_STRUCT_DESC: 30-inch coated steel drainage pipe through the levee, 2.5 feet below the crown. Pump in a pump house on the landside (LS) toe. Siphon breaker in a 24-inch steel riser on the waterside (WS). (Permit No. 17064, 1999 - Reclamation District No. 999).					
FS Date: 6/27/2013

Siphon breaker on WS shoulder.

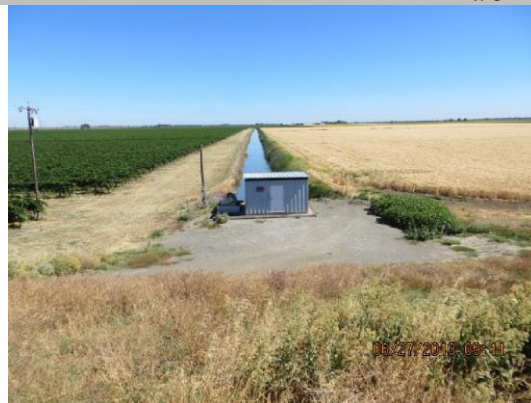
Photo 2 of 3 : UCIP\_SP\_2019\_16334\_27526.jpg

LM Start	1.25	Rating **	M	Issue No.	43 (cont)	
LM End	1.25	Issue Type +	En	Location *		
Category	Supplemental			GPS Latitude/Longitude		
				Start	End	
Item	DWR UCIP Field Study			38.291381 °	38.291381 °	
				-121.623268 °	-121.623268 °	
DWR ID	23963					
Comment Code						
Inspector Comment						
FS_ID:16334						
DS_ID:23963						
EP_NO: N/A						
Repair Type: Non-Urgent						
Crossing Status: Found						
UCIP Comments: Need to determine permit No. for this crossing.						
FIELD_STRUCT_DESC: 30-inch coated steel drainage pipe through the levee, 2.5 feet below the crown. Pump in a pump house on the landside (LS) toe. Siphon breaker in a 24-inch steel riser on the waterside (WS). (Permit No. 17064, 1999 - Reclamation District No. 999).						
FS Date: 6/27/2013

Pumphouse on LS toe.

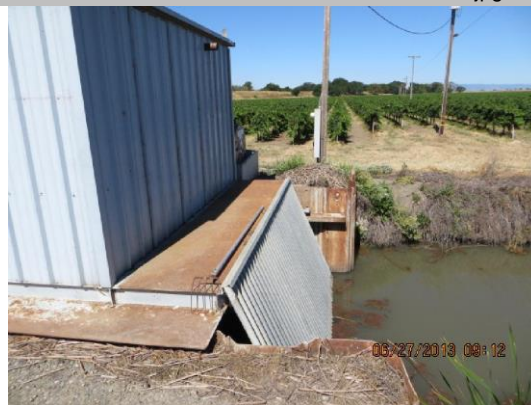
Photo 3 of 3 : UCIP\_SP\_2019\_16334\_27525.jpg

Pumphouse on LS toe with trash rack.

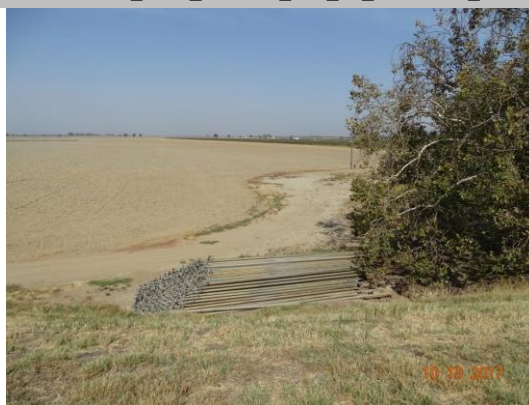
Photo 1 of 1 : SP\_2019\_RD0999\_233\_27\_20190307\_00022.jpg

LM Start	1.59	Rating **	M	Issue No.	27
LM End	1.66	Issue Type +	En	Location *	LS
Category	Earthen Levee			GPS Latitude/Longitude	
				Start	End
Item	Encroachments			38.290658 °	38.290376 °
				-121.617058 °	-121.615848 °
DWR ID	DWR_RD0999_02_f_2017_27				
Comment Code					
PI : Pipe					
Inspector Comment					
Landowner needs to move pipes to at least 10' away from levee toe.

View of equipment on landside slope looking north. Fall 2017

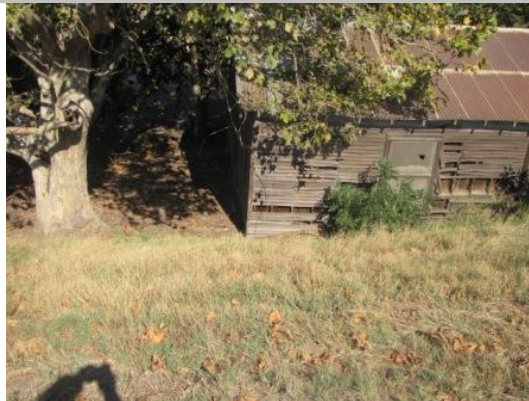
Photo 1 of 2 : SP\_2019\_RD0999\_233\_3\_20190307\_00003.jpg

LM Start	1.67	Rating **	U	Issue No.	3
LM End	1.68	Issue Type +	En	Location *	LS
Category	Earthen Levee			GPS Latitude/Longitude	
				Start	End
Item	Encroachments			38.290287 °	38.290217 °
				-121.615668 °	-121.615460 °
DWR ID	DWR_RD0999_02_s_2012_3				
Comment Code					
BU : Building					
Inspector Comment					
Old storage shed on landside toe and berm.

Looking north at building at landside toe.

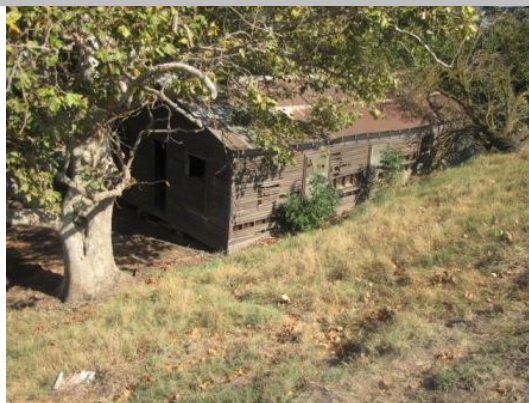
Photo 2 of 2 : SP\_2019\_RD0999\_233\_3\_20190307\_00004.jpg

Looking northeast at building at landside toe.

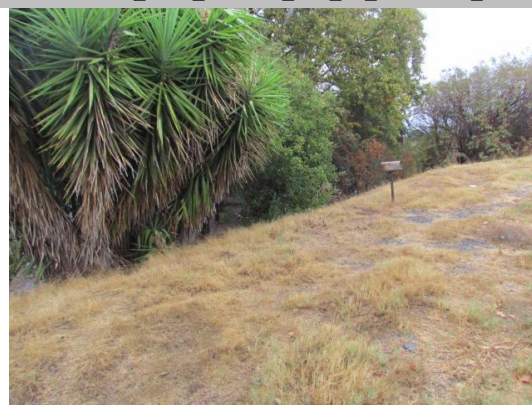
Photo 1 of 2 : SP\_2019\_RD0999\_233\_11\_20190307\_00009.jpg

LM Start	1.70	Rating **	U	Issue No.	11
LM End	1.70	Issue Type +	En	Location *	LS
Category	Earthen Levee			GPS Latitude/Longitude	
				Start	End
Item	Vegetation			38.290171 °	38.290171 °
				-121.615260 °	-121.615260 °
DWR ID	DWR_RD0999_02_s_2012_11				
Comment Code					
V6 : Landscaping					
Inspector Comment

Looking at dense trees on landward slope.

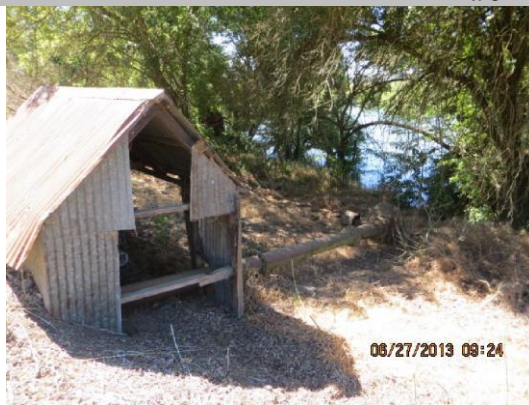
Photo 2 of 3 : UCIP\_SP\_2019\_15386\_25248.jpg

Pipe, pumphouse, and gate valve on WS slope.

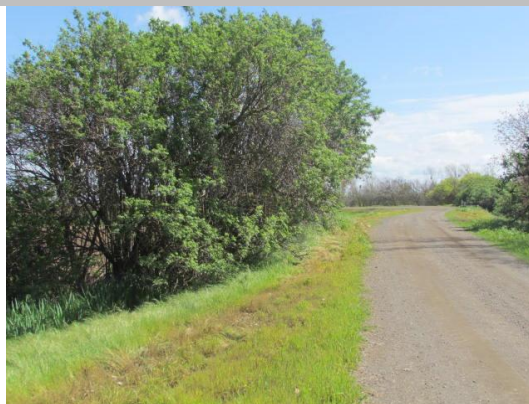
Photo 1 of 3 : SP\_2019\_RD0999\_233\_8\_20190307\_00005.jpg

LM Start	1.73	Rating **	M	Issue No.	8
LM End	1.76	Issue Type +	En	Location *	LS
Category	Earthen Levee			GPS Latitude/Longitude	
				Start	End
Item	Vegetation			38.289895 °	38.289595 °
				-121.614688 °	-121.614337 °
DWR ID	DWR_RD0999_02_s_2012_8				
Comment Code					
V6 : Landscaping					
Inspector Comment

Looking east at dense vegetation on landward shoulder and slope.  
(Spring 2016)

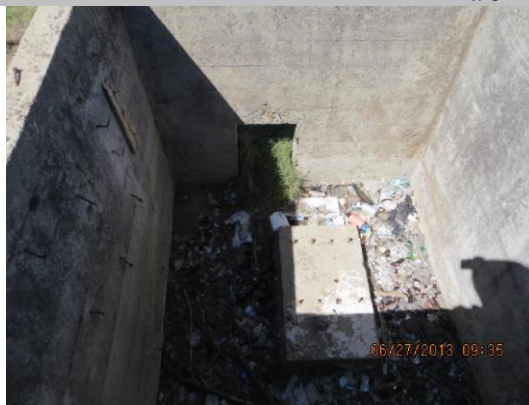
Photo 2 of 2 : UCIP\_SP\_2019\_41069\_25250.jpg

Pump mount inside foundation at WS slope.

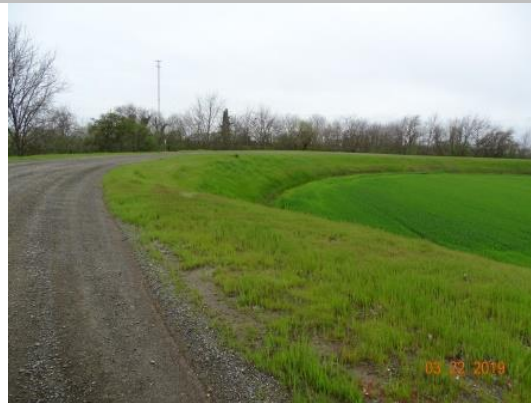
Photo 1 of 1 : SP\_2019\_RD0999\_233\_38\_20190327\_00048.jpg

LM Start	2.17	Rating **	A	Issue No.	38
LM End	2.30	Issue Type +	Ma	Location *	LS
Category	Earthen Levee			GPS Latitude/Longitude	
				Start	End
Item	Vegetation			38.287928 °	38.286575 °
				-121.607800 °	-121.606290 °
DWR ID	DWR_RD0999_02_s_2019_38				
Comment Code					
V1 : Control annual grass and weeds on the levee slopes and easements.					
Inspector Comment					
Vegetation in this section is well-maintained.

View of well-maintained landside vegetation. Spring 2019

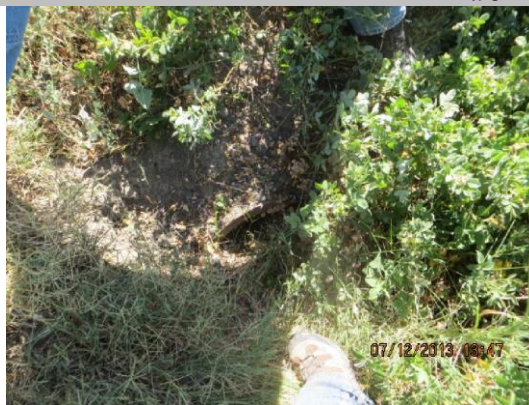
Photo 2 of 3 : UCIP\_SP\_2019\_15703\_26124.jpg

Pipe visible just off shoulder on LS slope in the rose bushes.

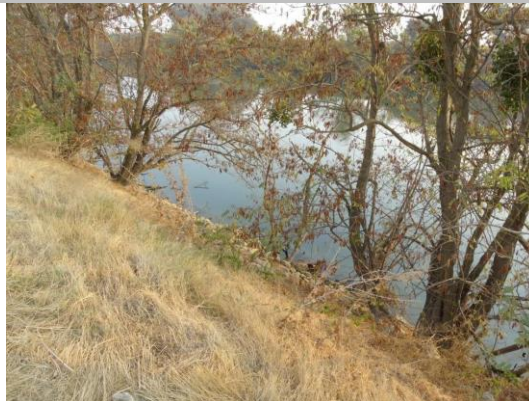
Photo 1 of 2 : SP\_2019\_RD0999\_234\_7\_20190307\_00001.jpg

LM Start	0.22	Rating **	A/W	Issue No.	7
LM End	0.22	Issue Type +	Ob	Location *	LS
Category	Supplemental			GPS Latitude/Longitude	
				Start	End
Item	2017 Storm Damage			38.289394 °	38.289394 °
				-121.604538 °	-121.604538 °
DWR ID	DWR_RD0999_03_f_2017_7				
Comment Code					
Inspector Comment					
Levee Evaluation Comments					
Description:					
Site ID No:114					
Site Designation:305-01					
Repair Type: Seepage					
Rating:					
Field Date:					
Notes: Spring 2019 DWR Inspection: No evidence of seepage at site.

View of waterside slope with some revetment at the water's edge. Fall 2018

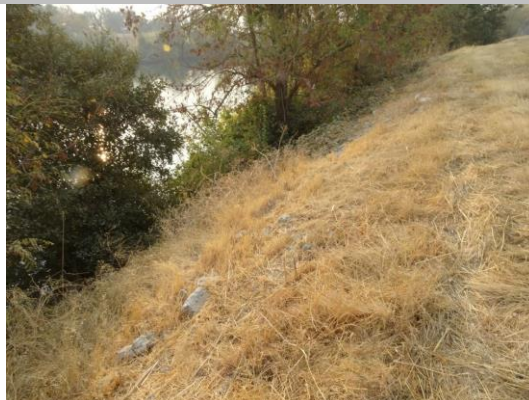
Photo 2 of 2 : SP\_2019\_RD0999\_234\_7\_20190307\_00002.jpg

View of waterside slope with some revetment. Fall 2018

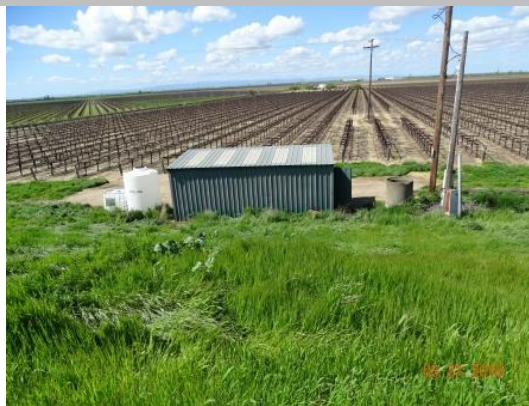
Photo 1 of 1 : SP\_2019\_RD0999\_234\_20\_20190327\_00033.jpg

LM Start	0.80	Rating **	U	Issue No.	20
LM End	0.80	Issue Type +	En	Location *	LS
Category	Earthen Levee			GPS Latitude/Longitude	
				Start	End
Item	Encroachments			38.297550 °	38.297550 °
				-121.605207 °	-121.605207 °
DWR ID	DWR_RD0999_03_s_2019_20				
Comment Code					
BU : Building					
Inspector Comment					
Shed and tank need to be moved at least 10' away from levee toe.

View looking west at shed and tank on landside levee easement. Spring 2019

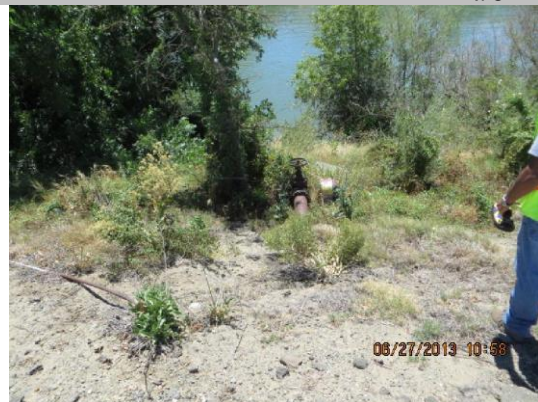
Photo 1 of 3 : UCIP\_SP\_2019\_15393\_25264.jpg

LM Start	2.00	Rating **	M	Issue No.	41
LM End	2.00	Issue Type +	En	Location *	
Category	Supplemental			GPS Latitude/Longitude	
				Start	End
Item	DWR UCIP Field Study			38.311709 °	38.311709 °
				-121.596713 °	-121.596713 °
DWR ID	22780				
Comment Code					
Inspector Comment					
FS_ID:15393					
DS_ID:22780					
EP_NO: N/A					
Repair Type: Non-Urgent					
Crossing Status: Found					
UCIP Comments: Pipe abandoned and should be done so properly.					
FIELD_STRUCT_DESC: 7-inch steel irrigation pipe through the levee,					
4.6 feet below the crown. Pump and gate valve on the waterside (WS)					
slope. Service pole on the landside (LS) slope. 1-inch galvanized iron					
electrical conduit at the same location. [Additional Reference(s): DWR					
Levee Log, 1992. USACE Sacramento O&M Manual 113 (Revised),					
October 1966, (HLM 2.01)].					
FS Date: 6/27/2013

Pipe visible on WS slope.

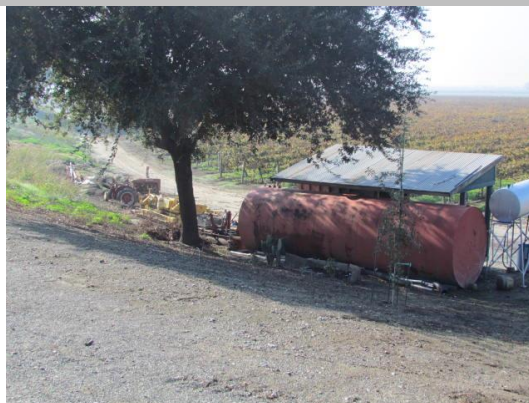
Photo 2 of 3 : SP\_2019\_RD0999\_234\_27\_20190307\_00018.jpg

LM Start	2.54	Rating **	U	Issue No.	27
LM End	2.54	Issue Type +	En	Location *	LS
Category	Earthen Levee			GPS Latitude/Longitude	
				Start	End
Item	Encroachments			38.317840 °	38.317840 °
				-121.590895 °	-121.590895 °
DWR ID	DWR_RD0999_03_s_2012_27				
Comment Code					
EQ : Equipment					
Inspector Comment					
Diesel tank and farming equipment need to be moved at least 10' away from the levee toe.

Looking southwest at farm equipment stored at landside toe. (Fall Inspection 2012)

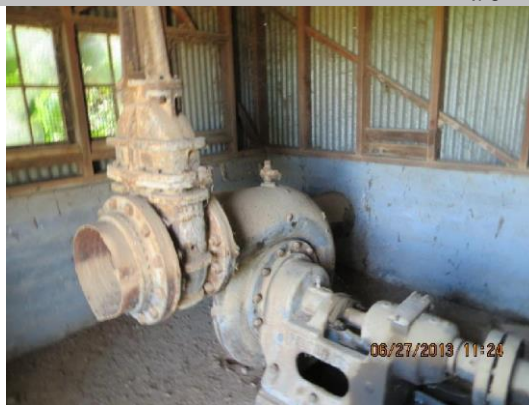
Photo 2 of 3 : UCIP\_SP\_2019\_15406\_25284.jpg

LM Start	2.88	Rating **	M	Issue No.	42
LM End	2.88	Issue Type +	En	Location *	
Category	Supplemental			GPS Latitude/Longitude	
				Start	End
Item	DWR UCIP Field Study			38.322652 °	38.322652 °
				-121.590841 °	-121.590841 °
DWR ID	22782				
Comment Code					
Inspector Comment					
FS_ID:15406 DS_ID:22782 EP_NO: N/A Repair Type: Non-Urgent Crossing Status: Found UCIP Comments: This pipe is abandoned and should be done so properly. FIELD_STRUCT_DESC: *ABANDONED* 16-inch steel drainage pipe through the levee, 9.3 feet below the crown. Pump and gate valve in pump house on the landside (LS) slope. [Additional Reference(s): DWR Levee Log, 1992. USACE Sacramento O&M Manual 113 (Revised), October 1966, (HLM 2.91)]. FS Date: 6/27/2013

Pump and gatevalve inside pumphouse at LS toe.

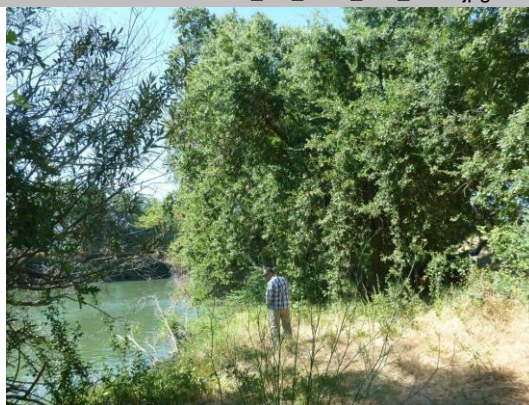
Photo 1 of 3 : LEVAL\_SP\_2019\_356\_2492.jpg

LM Start	3.18	Rating **	A/W	Issue No.	15
LM End	3.21	Issue Type +	Ma	Location *	WS
Category	Supplemental			GPS Latitude/Longitude	
				Start	End
Item	2017 Storm Damage			38.325053 °	38.325489 °
				-121.586347 °	-121.586100 °
DWR ID	DWR_RD0999_03_f_2017_15				
Comment Code					
Inspector Comment					
Levee Evaluation Comments					
Description:The damage consists of erosion of the lower waterside levee slope and bank approximately 172 feet in length along the west (right) bank of Sutter Slough. See attached pages for photos. Site location T06N R04E Section 3 and 4.					
Site ID No:356					
Site Designation:LMA-183					
Repair Type: Erosion					
Rating:Area of Concern					
Field Date:7/27/2017					
Notes: 2018 DWR Inspector: Erosion not visible from levee slope.

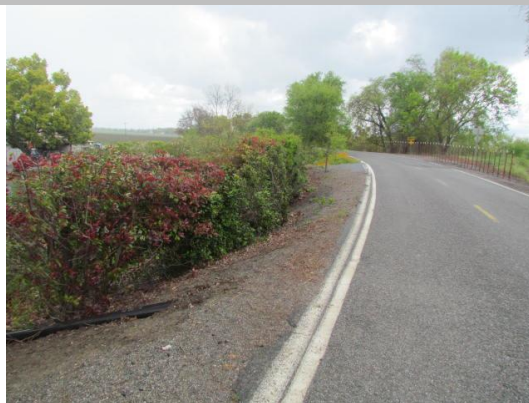
Photo 1 of 1 : SP\_2019\_RD0999\_234\_22\_20190307\_00013.jpg

LM Start	3.69	Rating **	M	Issue No.	22
LM End	3.71	Issue Type +	En	Location *	LS
Category	Earthen Levee			GPS Latitude/Longitude	
				Start	End
Item	Vegetation			38.331969 °	38.332156 °
				-121.584860 °	-121.584707 °
DWR ID	DWR_RD0999_03_s_2012_22				
Comment Code					
V6 : Landscaping					
Inspector Comment

Looking southwest at trimmed landscaping on landside slope that still blocks levee slope.

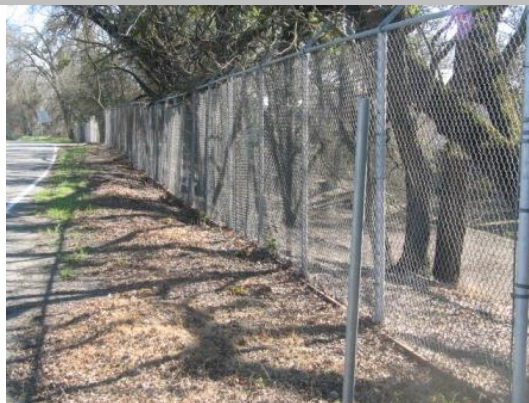
Photo 1 of 1 : SP\_2019\_RD0999\_235\_13\_20190307\_00006.jpg

LM Start	0.05	Rating **	M	Issue No.	13
LM End	0.11	Issue Type +	En	Location *	LS
Category	Earthen Levee			GPS Latitude/Longitude	
				Start	End
Item	Encroachments			38.414617 °	38.415467 °
				-121.523499 °	-121.524022 °
DWR ID	DWR_RD0999_04_s_2012_13				
Comment Code					
FE : Fence					
Inspector Comment

Cyclone fence along landside shoulder at LM 0.05 -0.11

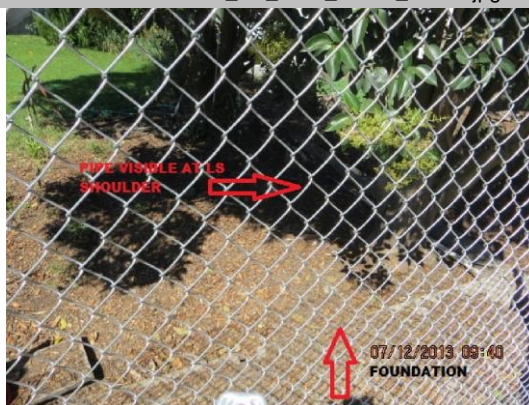
Photo 1 of 3 : UCIP\_SP\_2019\_15709\_26140.jpg

Comment Code					
Inspector Comment					
FS_ID:15709 DS_ID:22789 EP_NO: N/A Repair Type: Non-Urgent Crossing Status: Found UCIP Comments: Pipe abandoned and should be done so properly. FIELD_STRUCT_DESC: *ABANDONED* 2-inch steel pipe of unknown purpose through the levee, 4.5 feet below the crown. Concrete blocks for missing pump and pressure system visible on the waterside (WS) slope. 8-inch steel standpipe on the WS toe with remnants of the 2-inch pipe visible at the top. Pipe visible at concrete foundation on the landside (LS) shoulder. [Additional Reference(s): DWR Levee Log, 1992. USACE Sacramento O&M Manual 113 (Revised), October 1966, (HLM 0.02)]. FS Date: 7/12/2013

Pipe visible at concrete foundation on LS shoulder.

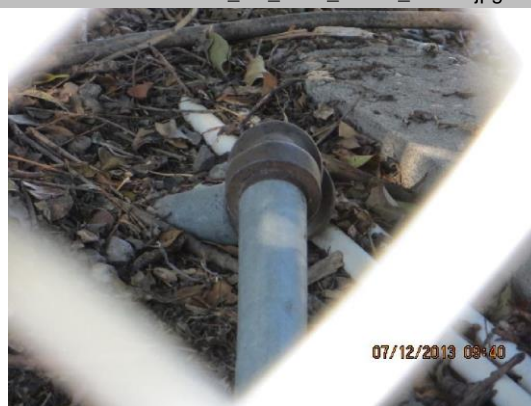
Photo 2 of 3 : UCIP\_SP\_2019\_15709\_26139.jpg

Comment Code						
Inspector Comment						
FS_ID:15709 DS_ID:22789 EP_NO: N/A Repair Type: Non-Urgent Crossing Status: Found UCIP Comments: Pipe abandoned and should be done so properly. FIELD_STRUCT_DESC: *ABANDONED* 2-inch steel pipe of unknown purpose through the levee, 4.5 feet below the crown. Concrete blocks for missing pump and pressure system visible on the waterside (WS) slope. 8-inch steel standpipe on the WS toe with remnants of the 2-inch pipe visible at the top. Pipe visible at concrete foundation on the landside (LS) shoulder. [Additional Reference(s): DWR Levee Log, 1992. USACE Sacramento O&M Manual 113 (Revised), October 1966, (HLM 0.02)]. FS Date: 7/12/2013

Pipe visible at concrete foundation on LS shoulder.

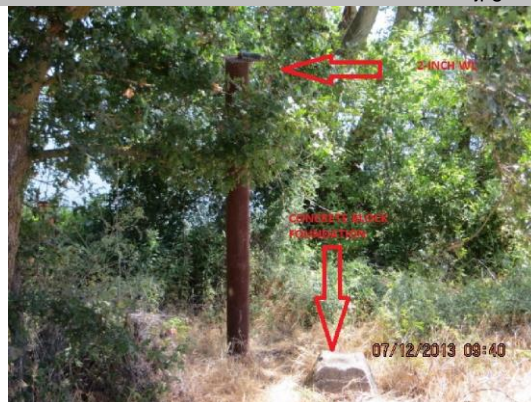
Photo 3 of 3 : UCIP\_SP\_2019\_15709\_26138.jpg

Pipe visible at top of steel standpipe. Foundation for pump station visible on WS slope.

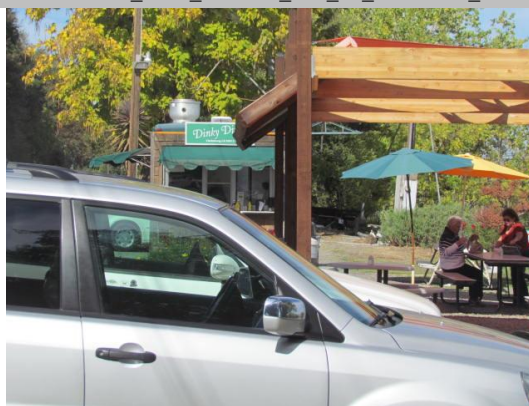
Photo 2 of 3 : SP\_2019\_RD0999\_235\_36\_20190307\_00012.jpg

LM Start	0.29	Rating **	U	Issue No.	36 (cont)	
LM End	0.29	Issue Type +	En	Location *	WS	
Category	Earthen Levee			GPS Latitude/Longitude		
				Start		End
Item	Encroachments			38.417809 °		38.417809 °
				-121.525488 °		-121.525488 °
DWR ID	DWR_RD0999_04_f_2014_36					
Comment Code						
BU : Building						
Inspector Comment						
Land owner built patio structure next to mobile diner on waterside shoulder area without Board permit.

Looking north at patio structure on waterward shoulder.

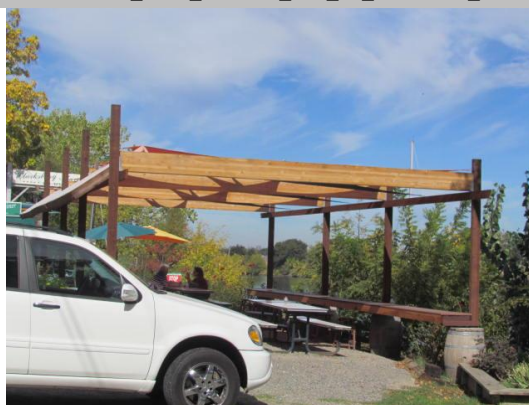
Photo 3 of 3 : SP\_2019\_RD0999\_235\_36\_20190307\_00013.jpg

Looking northeast at patio structure on waterward shoulder.

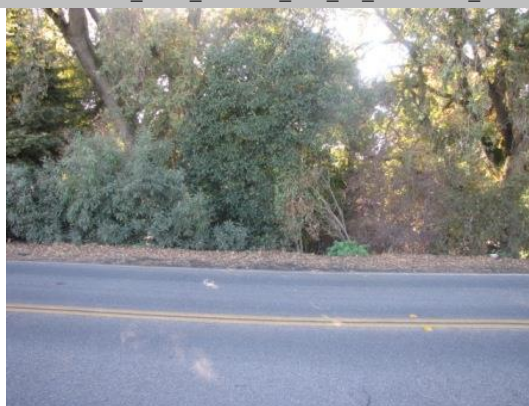
Photo 1 of 2 : SP\_2019\_RD0999\_235\_12\_20190307\_00004.jpg

LM Start	0.31	Rating **	U	Issue No.	12
LM End	0.35	Issue Type +	En	Location *	LS
Category	Earthen Levee			GPS Latitude/Longitude	
				Start	End
Item	Vegetation			38.417962 °	38.418449 °
				-121.525709 °	-121.526015 °
DWR ID	DWR_RD0999_04_s_2012_12				
Comment Code					
V6 : Landscaping					
Inspector Comment

Looking west at dense vegetation on landside slope and toe.

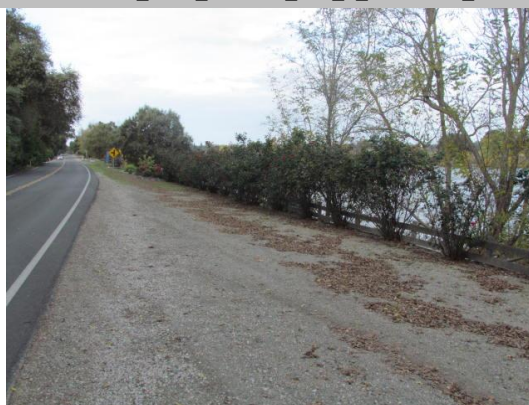
Photo 1 of 1 : SP\_2019\_RD0999\_235\_1\_20190307\_00001.jpg

LM Start	0.36	Rating **	M	Issue No.	1
LM End	0.47	Issue Type +	En	Location *	WS
Category	Earthen Levee			GPS Latitude/Longitude	
				Start	End
Item	Vegetation			38.418593 °	38.420004 °
				-121.526024 °	-121.526962 °
DWR ID	DWR_RD0999_04_s_2012_1				
Comment Code					
V6 : Landscaping					
Inspector Comment					
Landscaping belongs to Marina, according to LMA, and Permit 3083 does not include plantings.

Looking north at rose bushes on waterside slope.

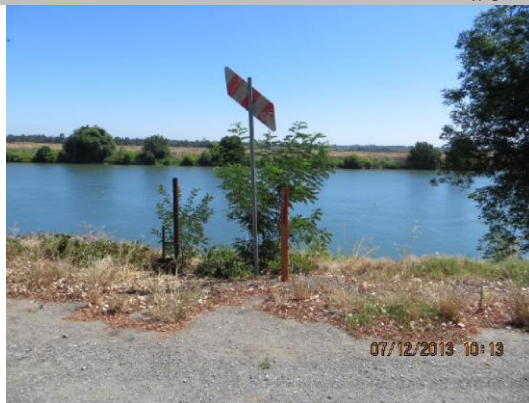
Photo 1 of 3 : UCIP\_SP\_2019\_15712\_26150.jpg

LM Start	0.71	Rating **	M	Issue No.	56	
LM End	0.71	Issue Type +	En	Location *		
Category	Supplemental			GPS Latitude/Longitude		
				Start		End
Item	DWR UCIP Field Study			38.423062 °	38.423062 °	
				-121.529241 °	-121.529241 °	
DWR ID	22791					
Comment Code						
Inspector Comment						
FS_ID:15712						
DS_ID:22791						
EP_NO: 3973						
Repair Type: Non-Urgent						
Crossing Status: Found						
UCIP Comments: Slide gate broken on LS toe. Appears it may be abandoned.						
FIELD_STRUCT_DESC: 18-inch steel drainage pipe through the levee, 4.7 feet below the crown. Air vent in an 18-inch steel standpipe on the waterside (WS) shoulder. Gate valve on the landside (LS) toe. (Permit No. 3973, 1962 - American Crystal Sugar Company). [Additional Reference(s): DWR Levee Log, 1992. USACE Sacramento O&M Manual 113 (Revised), October 1966, (HLM 0.71)].						
FS Date: 7/12/2013

Air vent in standpipe on WS shoulder.

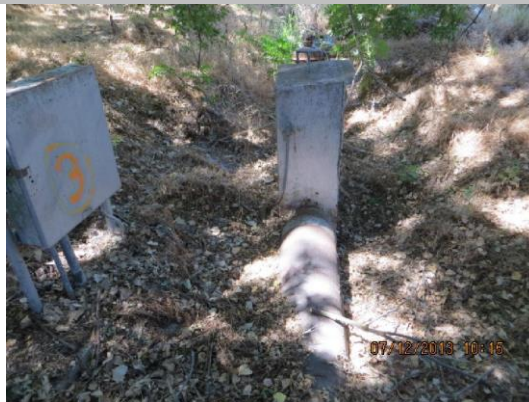
Photo 2 of 3 : UCIP\_SP\_2019\_15712\_26149.jpg

Electrical panel, water meter, and gate valve on LS toe.

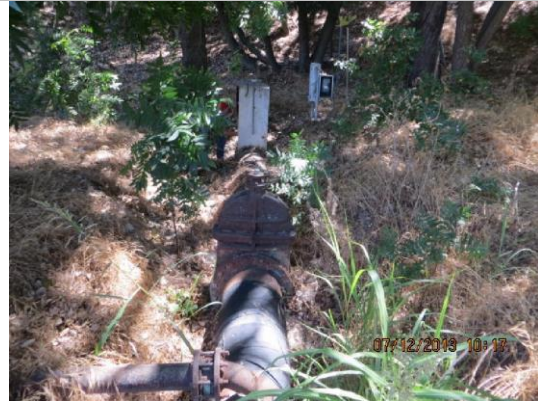
Photo 3 of 3 : UCIP\_SP\_2019\_15712\_26148.jpg

Gate valve on LS toe.

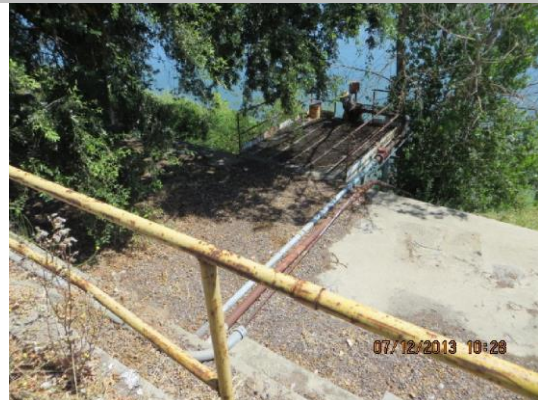
Photo 1 of 3 : UCIP\_SP\_2019\_15725\_26181.jpg

LM Start	0.74	Rating **	M	Issue No.	57
LM End	0.74	Issue Type +	En	Location *	
Category	Supplemental			GPS Latitude/Longitude	
				Start	End
Item	DWR UCIP Field Study			38.423418 °	38.423418 °
				-121.529486 °	-121.529486 °
DWR ID	22796				
Comment Code					
Inspector Comment					
FS_ID:15725 DS_ID:22796 EP_NO: 10514 Repair Type: Non-Urgent Crossing Status: Found UCIP Comments: Pipe appears abandoned and should be done so properly. FIELD_STRUCT_DESC: 1 of 3: 3.5-inch discharge pipe of an unknown material through the levee, 3.8 feet below the crown. Siphon breaker at headwall on the waterside (WS) slope. (Permit No. 10514, 1975 - The Newhall Land and Farming Company). [Additional Reference(s): DWR Levee Log, 1992]. FS Date: 7/12/2013

Discharge pipe at concrete pad then down slope to water.
